White River Bank Stabilization Update (ANRC 09-1900)

Reducing Sediment and Nutrient Loadings through River and Streambank Restoration in the Beaver Lake Watershed

Matt Van Eps, Watershed Conservation Resource Center
ANRC 2014 NPS Annual Meeting
September 17 and 18, 2014

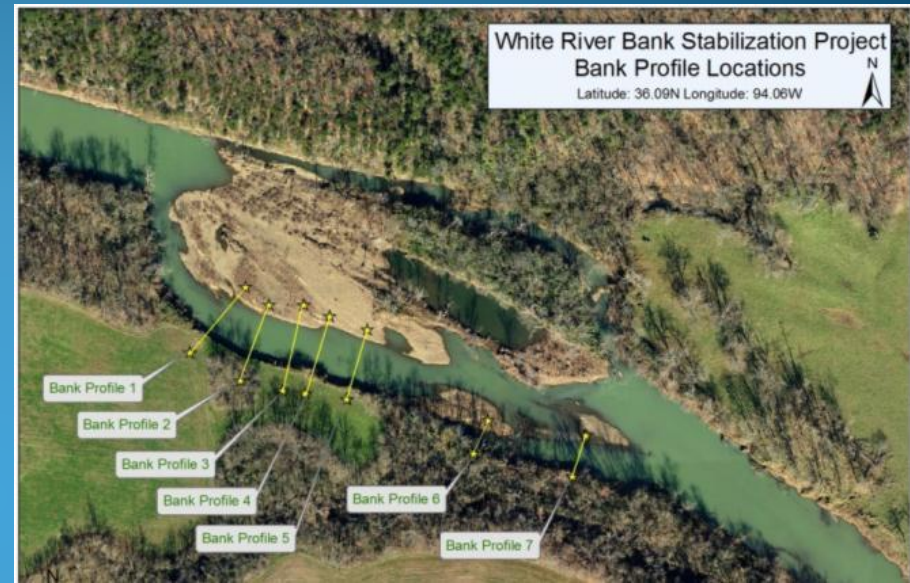
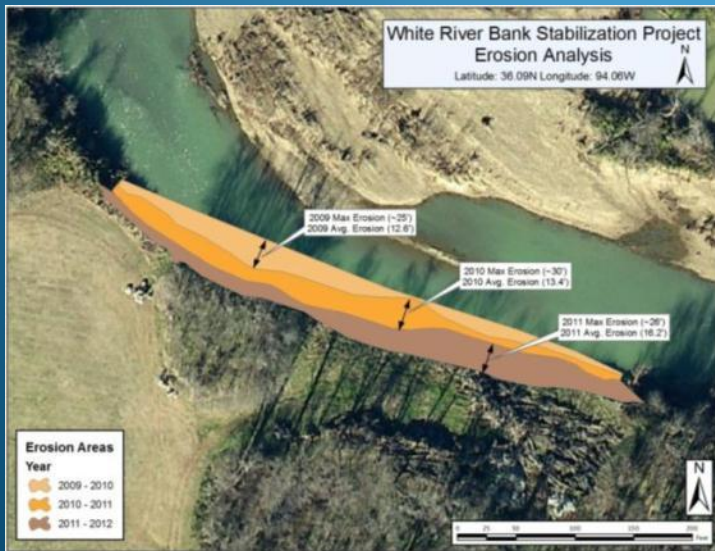
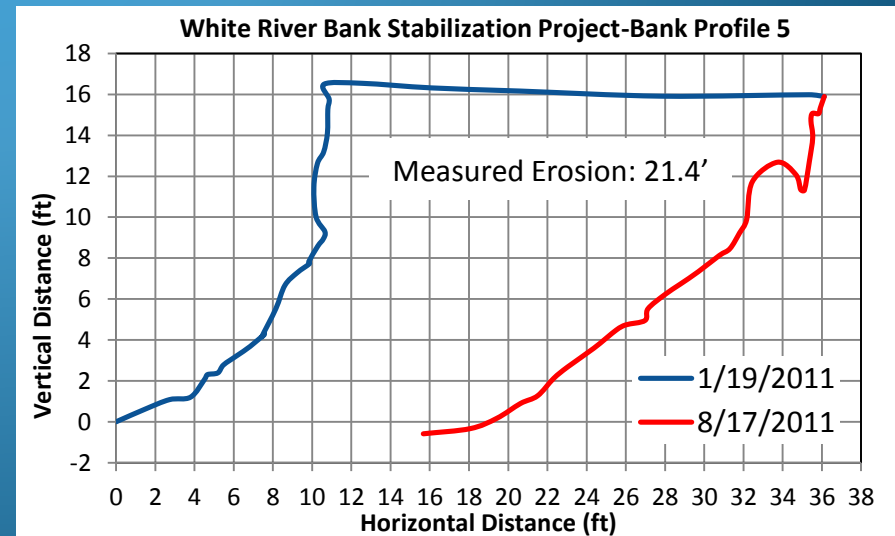
Pre-Restoration Site Monitoring

- Bank Erosion Monitoring Results
 - Ranged from 3.1 to 21.7 feet over a 7 month period
 - Included two major flood events - April and May 2011
- Air Photo Evaluation of Lateral Bank Erosion - 2009 - 2011
 - **Average rate over three years was 14 ft/year**

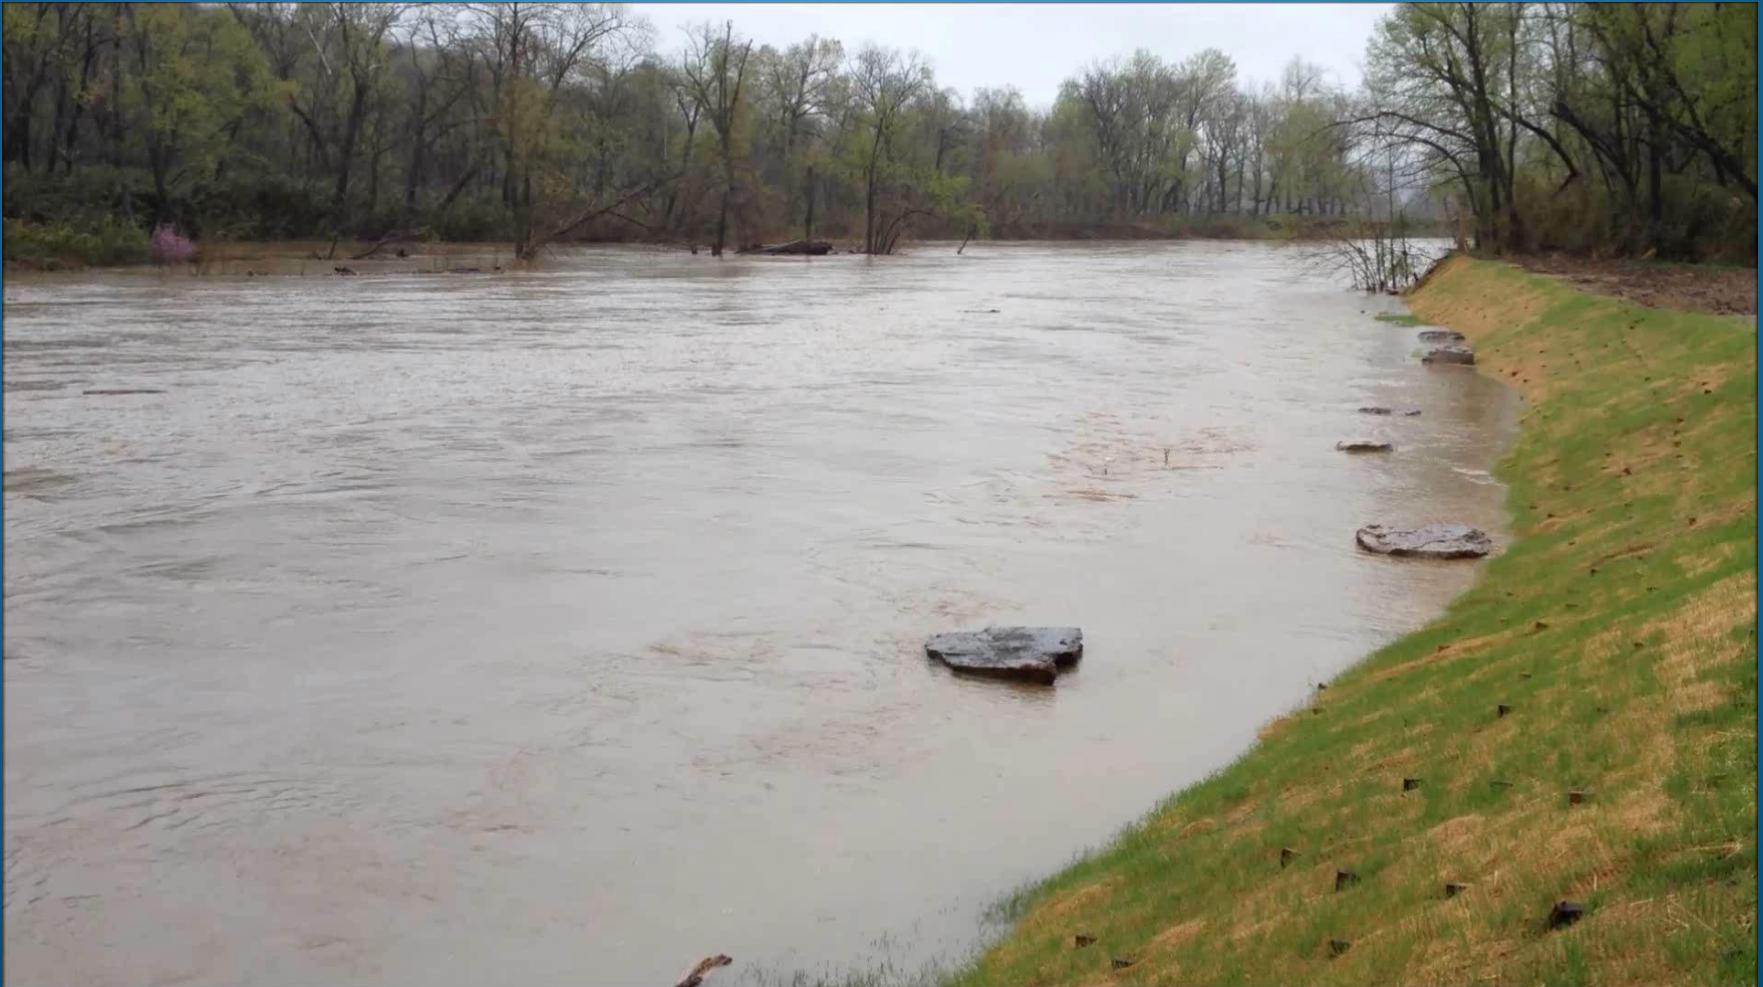
- If you need rain, build a stream restoration
- Two weeks following construction, 13,000 cfs peak flow (bankfull Q is 11,500 cfs)
