Sager Creek Urban Stream Restoration Phase 2

319 Grant Project No. 09-1300

**Funded by: EPA Region 6, ANRC and the City of
Siloam Springs**

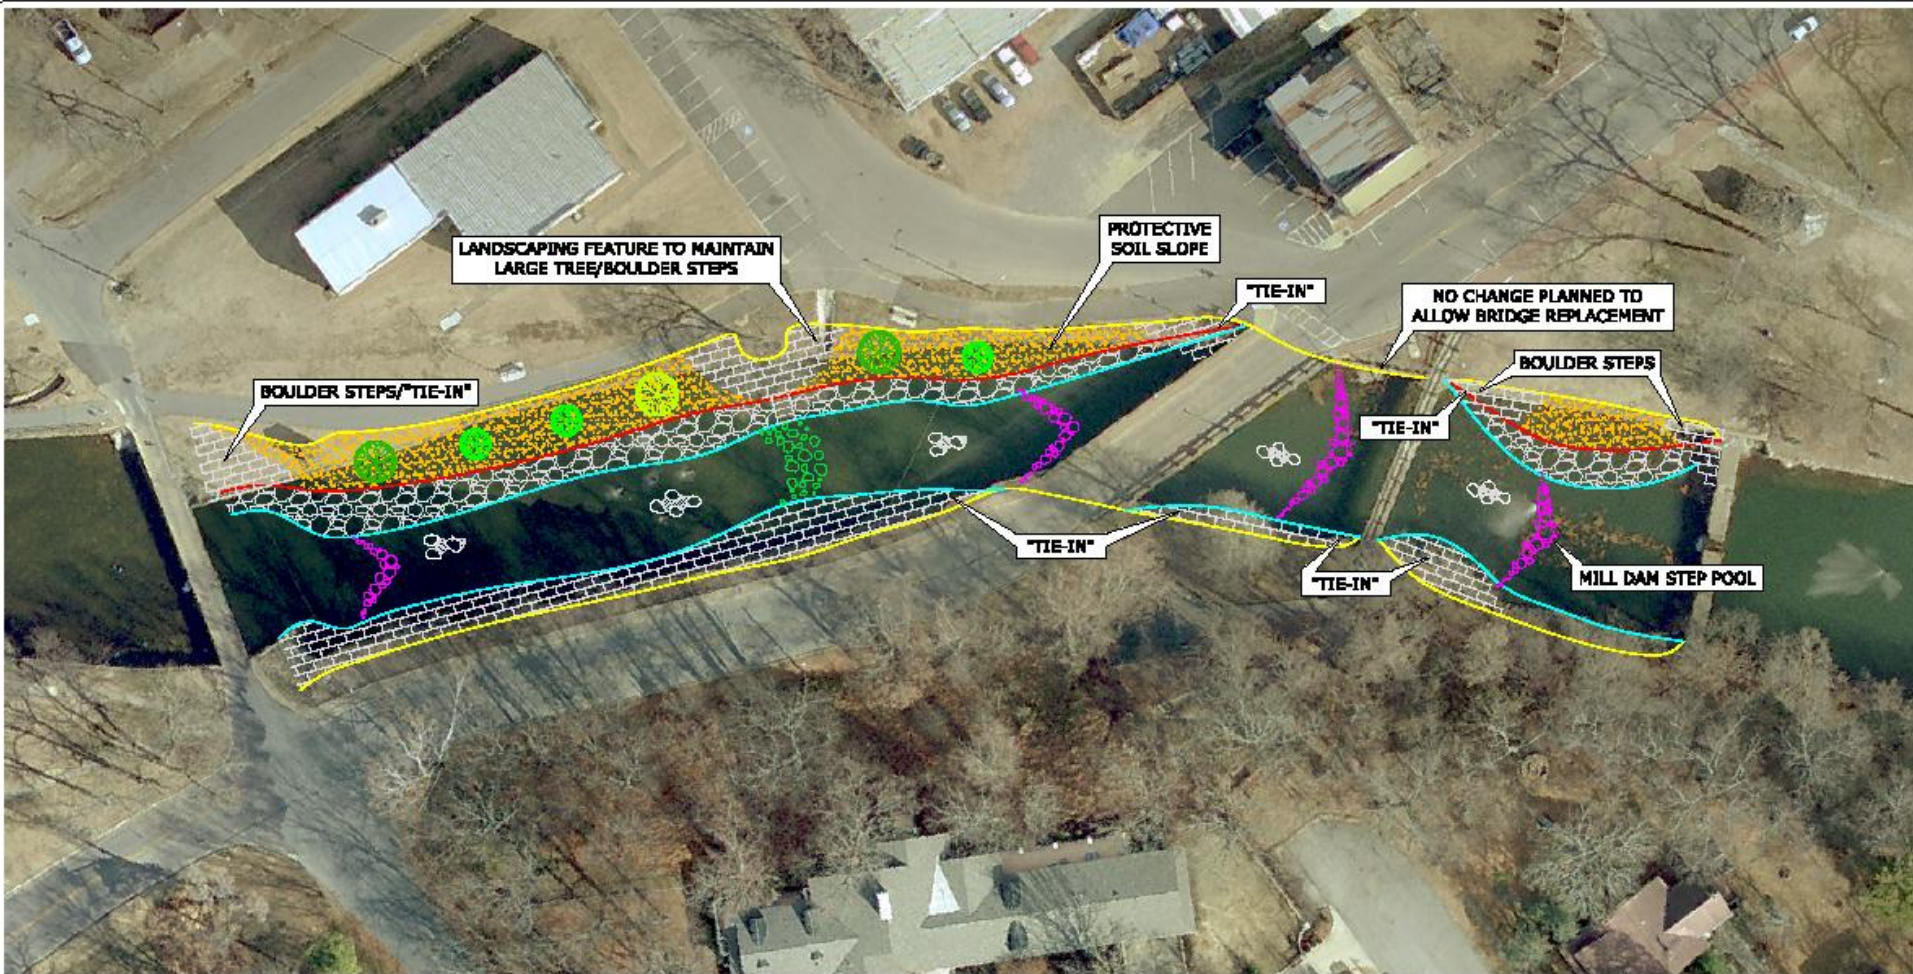
Restoration Layout

4600.900.006			
SAGER CREEK RESTORATION DESIGN LAYOUT DETAIL			
CITY OF SILDAM SPRINGS SILDAM SPRINGS, ARKANSAS			
Approved by:	SKH/CDC	 	Project No.: 4800-10-900
Checked by:	JdF	Date:	09/10/2010
Drawn by:	IT	Scale:	SHOWN

- ◆ **Restoration design and hydraulic modeling**
- ◆ **Re-shaping of stream banks**
- ◆ **Construction of sloped or stepped boulder revetments (imbricated rip rap)**
- ◆ **Construction of bankfull bench and boulder toes**
- ◆ **Constructing of step pools and/or riffles and boulder clusters**
- ◆ **Planting of native riparian vegetation**

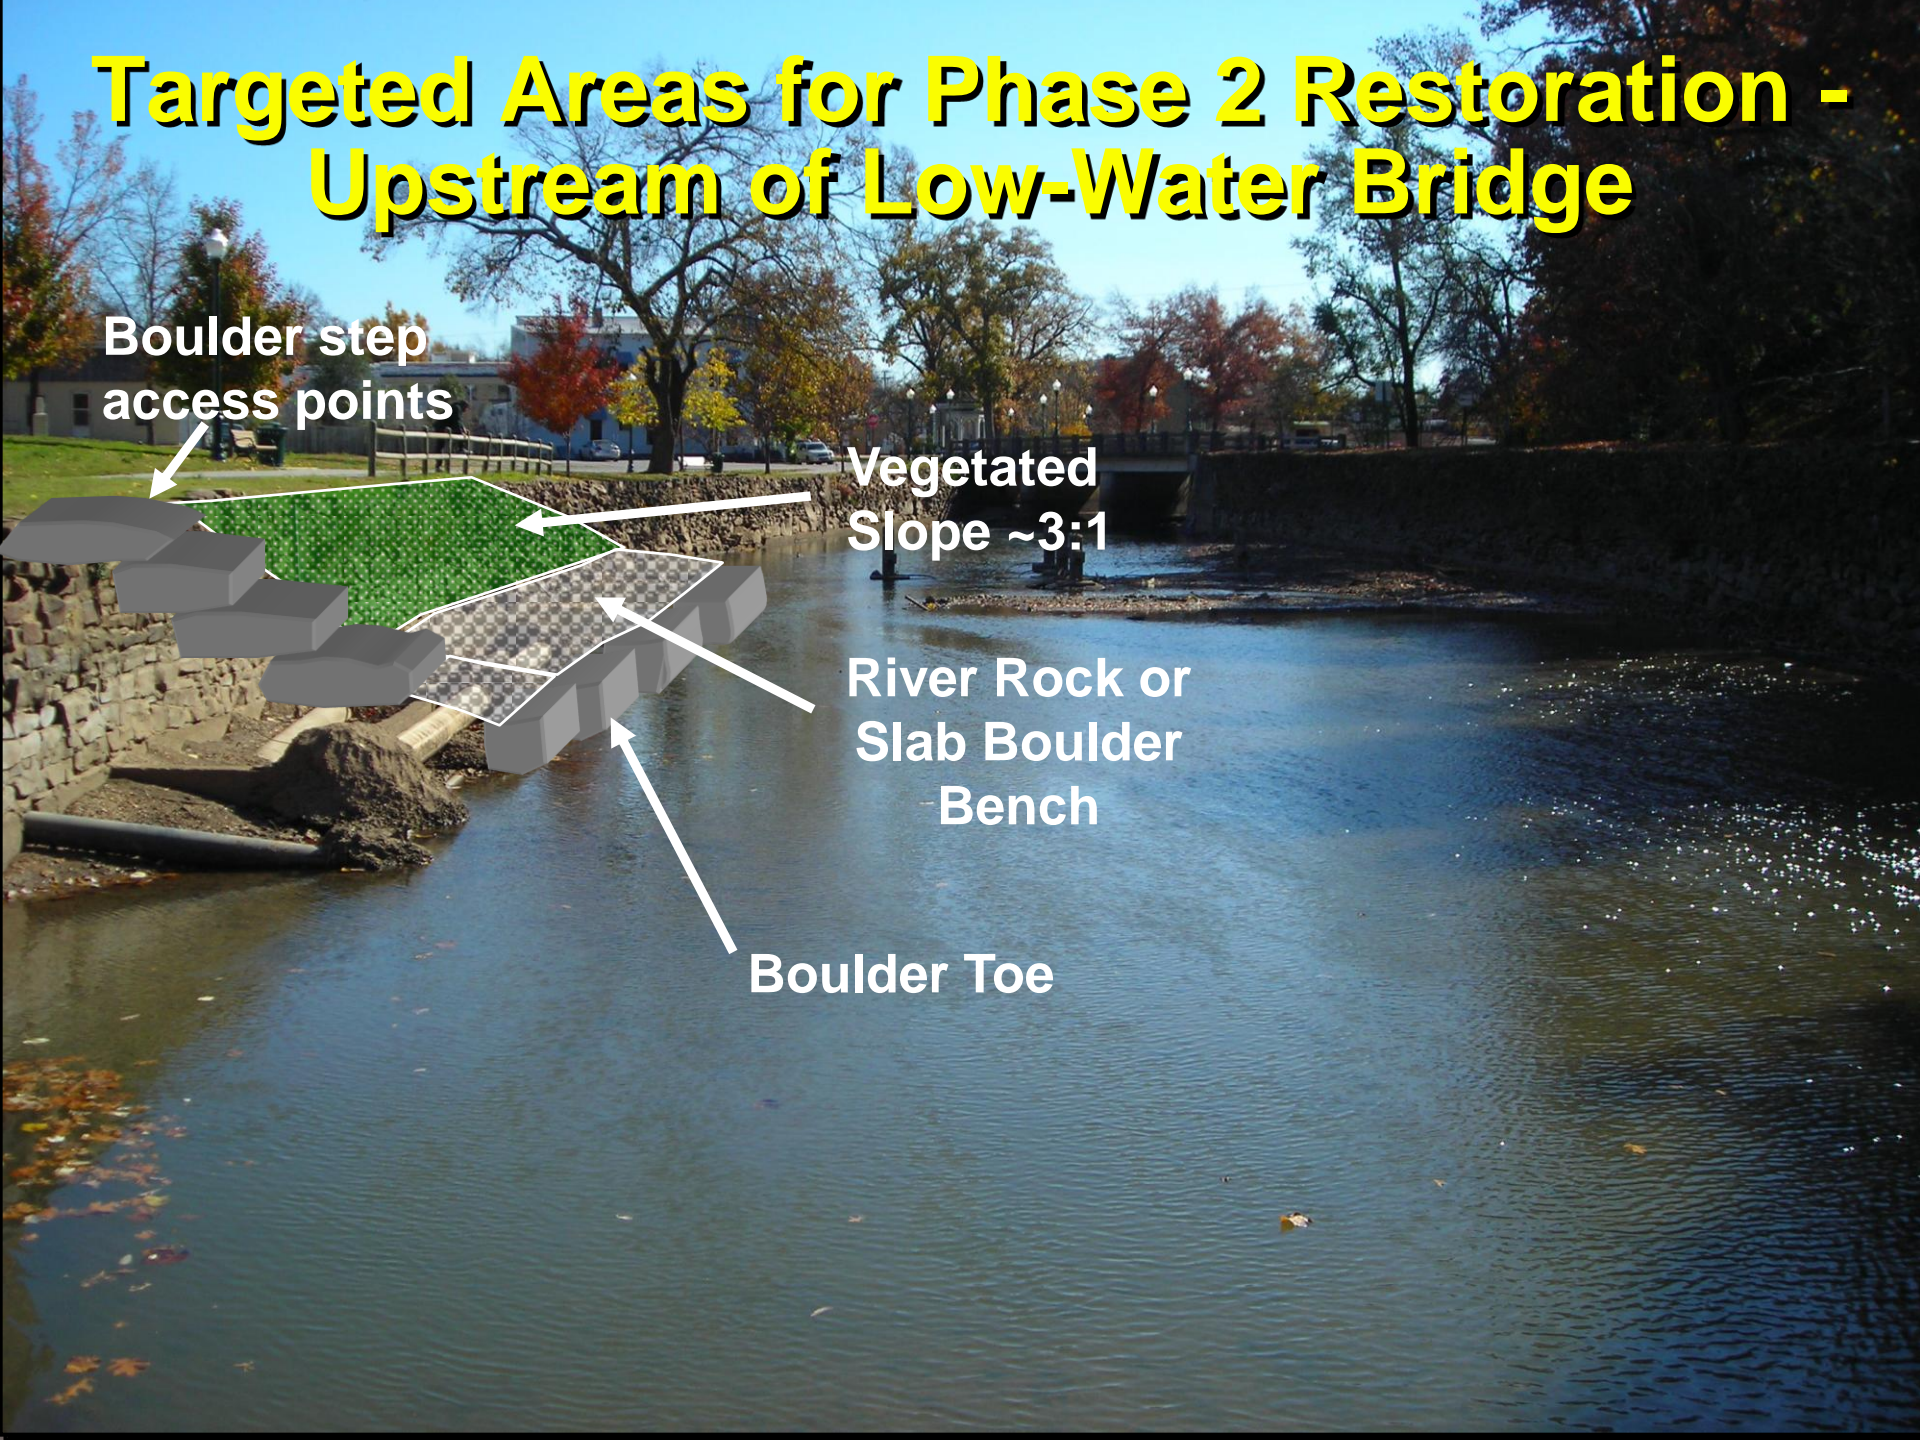
Targeted Areas for Phase 2 Restoration - Upstream of Low-Water Bridge

Boulder step
access points

Vegetated
Slope ~3:1

River Rock or
Slab Boulder
Bench

Boulder Toe

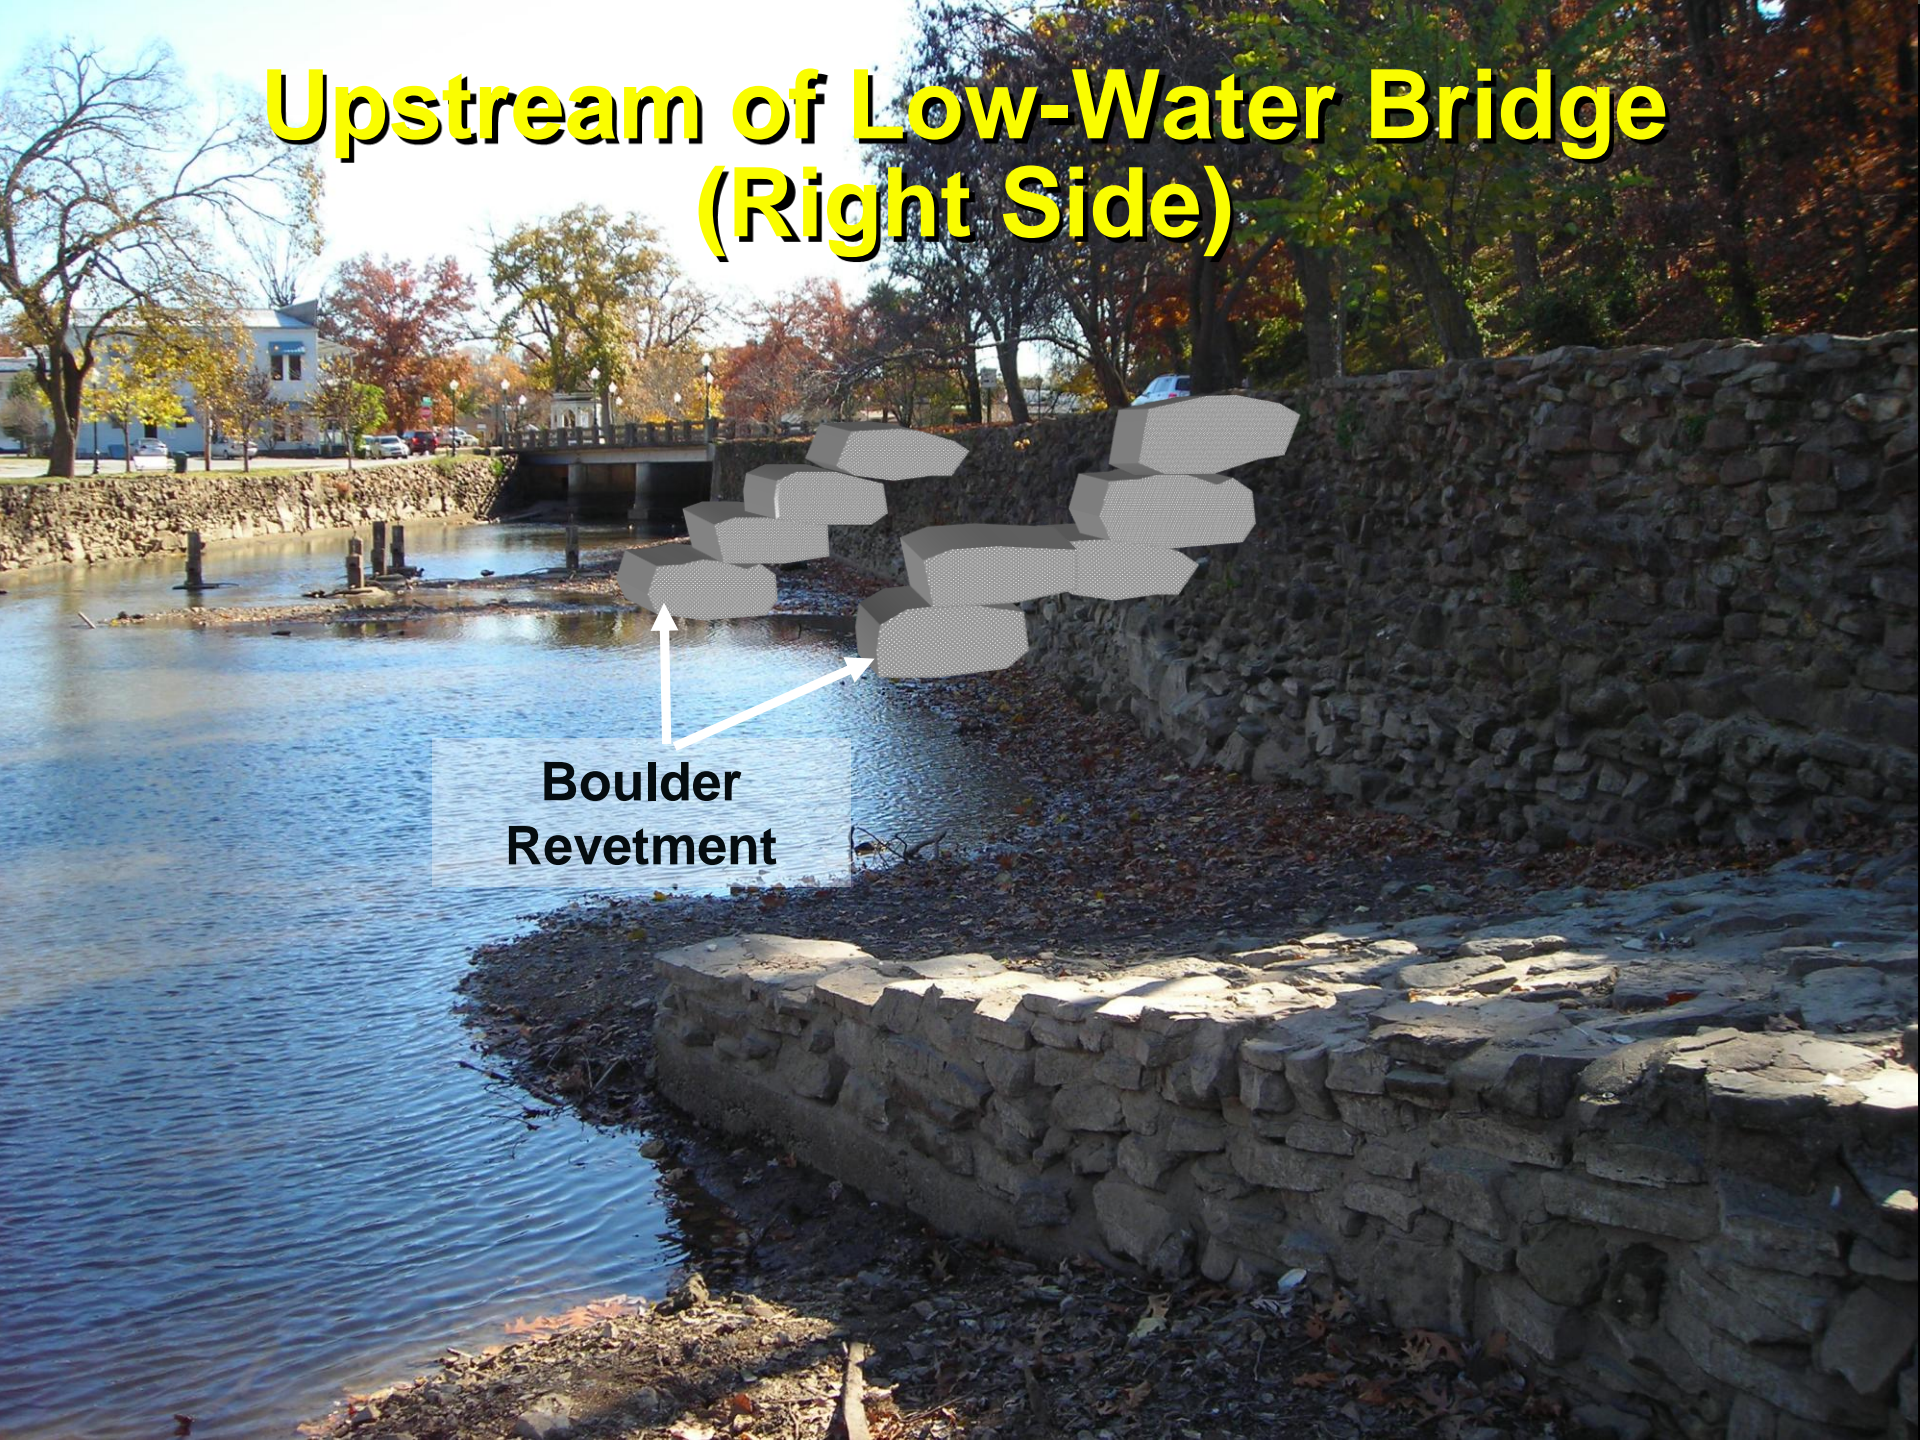
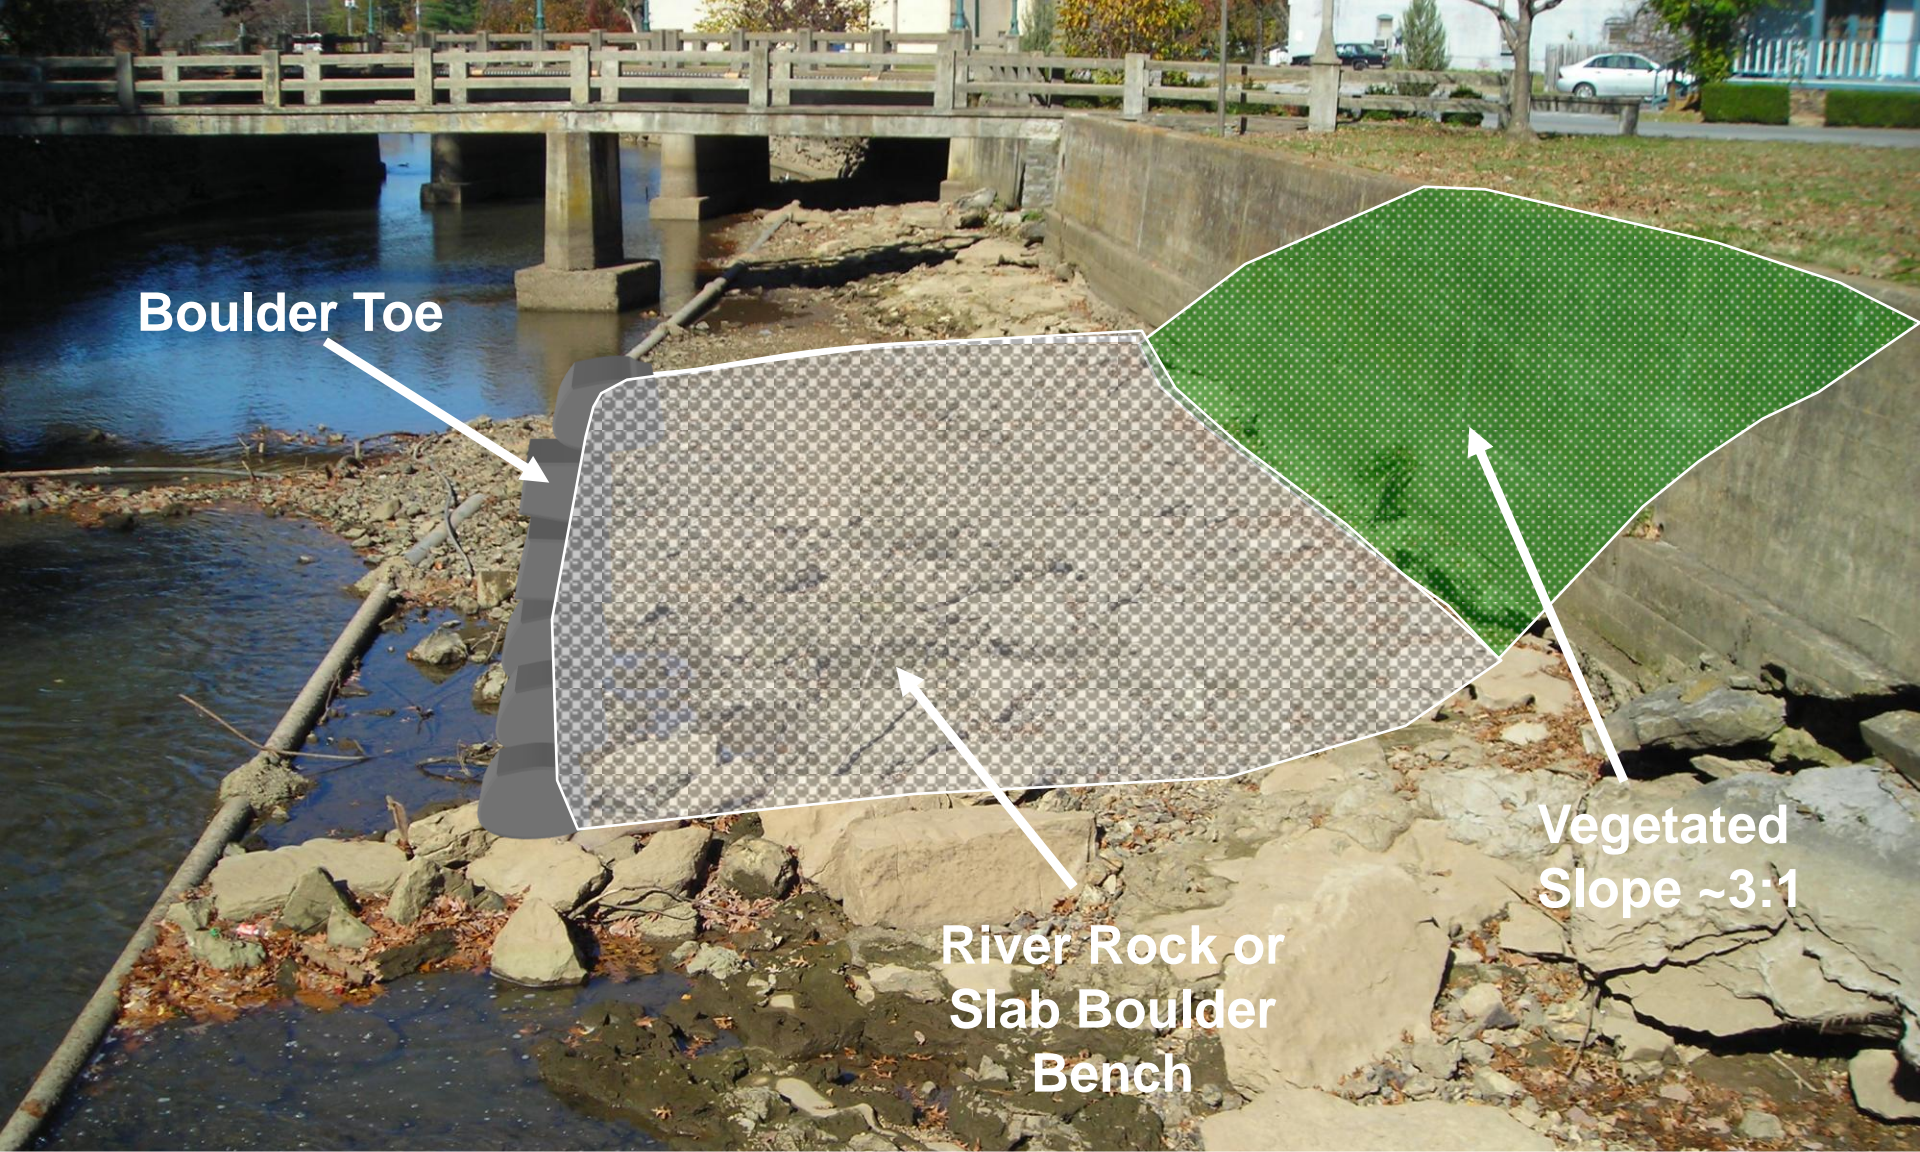
Upstream of Low-Water Bridge (Right Side)

Boulder
Revetment

Boulder Toe

River Rock or
Slab Boulder
Bench

Vegetated
Slope ~3:1

Area immediately below large dam in City Park. This is the upstream limit of the Phase 2 restoration effort in the main channel

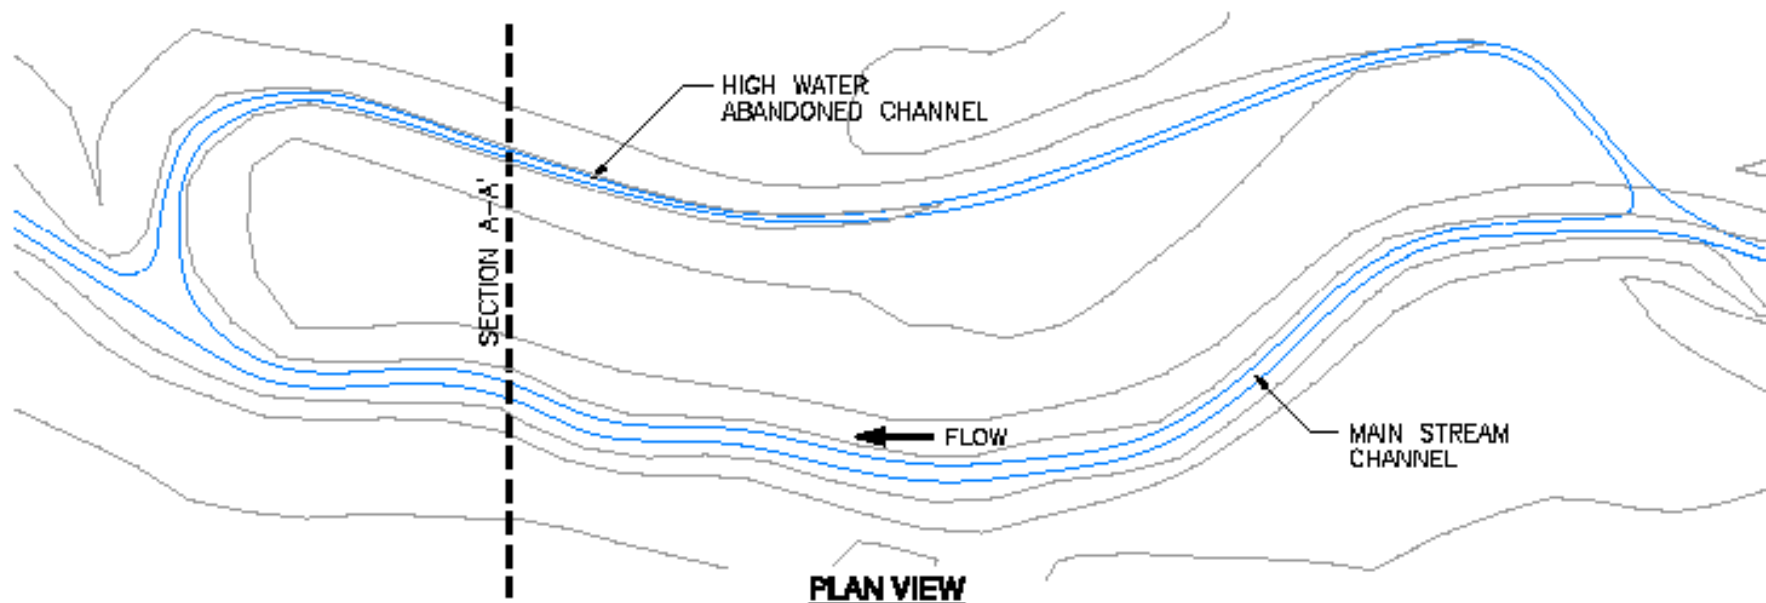
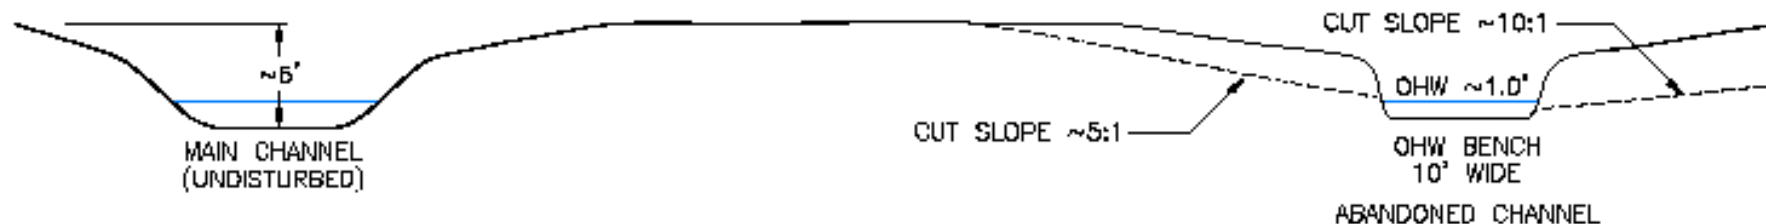
UTS-1 Design Concept

SECTION A-A'

4600.900.005			
UTS-1 CHANNEL RECONFIGURATION/ENHANCEMENT PLAN & CROSS-SECTION CITY OF SILOAM SPRINGS SILOAM SPRINGS, ARKANSAS			
Approved by:	CLP	GBM CONSULTANTS	Project No.:
Directed by:	CLP		Date:
Drawn by:	IT		Scale:
			4600-10-900 06/08/2010 NTS
